REHABEND 2022

CONSTRUCTION
PATHOLOGY,
REHABILITATION
TECHNOLOGY AND
HERITAGE MANAGEMENT

3. PLAN DE INSPECCIÓN Y ENSAYOS

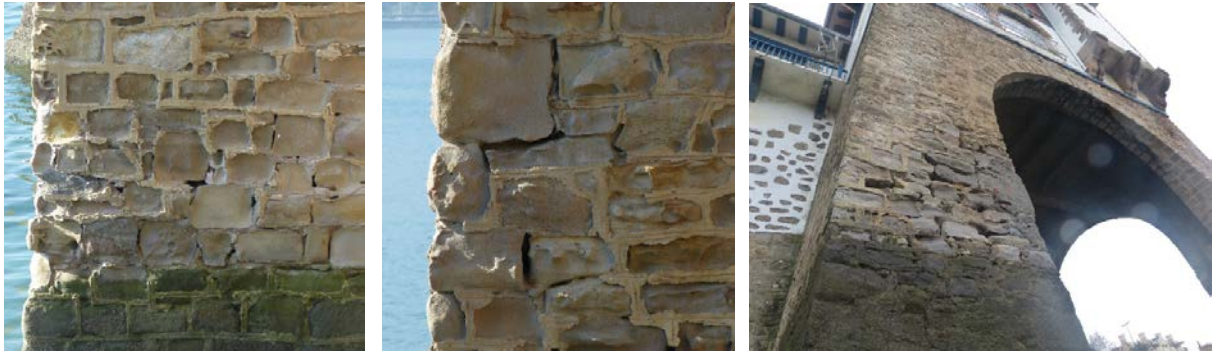
Comenzando por las fachadas, estas presentan en su casi totalidad mampostería de arenisca a la vista desde la planta baja hasta el muelle o hasta el lecho rocoso. Los muros cuentan además con función estructural. Los tramos no expuestos directamente al agua de mar presentan un estado de conservación aceptable, con diferentes intervenciones a lo largo de la vida del edificio, coexistiendo morteros de rejunteo originales y de reposición, con otros tramos donde éste se ha perdido en su casi totalidad. Sin embargo, los mayores daños se concentran en todos los tramos en contacto con el agua marina, especialmente en la zona bajo el faro. Se aprecian importantes pérdidas de sección e incluso fuertes alveolizaciones, deplacaciones y arenizaciones por encima de la zona de carrera de mareas. En las zonas del basamento de las fachadas Sur y Este, así como en el muro no visible desde el exterior paralelo a la fachada Este, se observa la presencia de colonizaciones de organismos marinos en la zona de carrera de mareas. Algunas imágenes pueden verse en la Figura 5.

Figura 5: Aspecto de la arenisca y de los morteros en la zona de carrera de mareas.

En lo referente a los muros de mampostería y dada su función estructural, habría que reponer las secciones perdidas, especialmente en las fachadas Este y Sur, en la zona de carrera de mareas. Para ello, se emplearán materiales pétreos y morteros de características similares a los ya caracterizados (morteros originales), en aspectos tales como su porosidad, color, propiedades hídrica y mecánicas. Se recomienda eliminar los morteros de rejunteo no originales, a excepción de la fachada Norte, en la que los daños en la piedra son muy reducidos, y su eliminación produciría desperfectos superiores. Cuando la piedra ha quedado rehundida respecto al mortero y no se vaya a intervenir sobre ella, se aconseja eliminar el mortero antiguo y colocar otro nuevo.

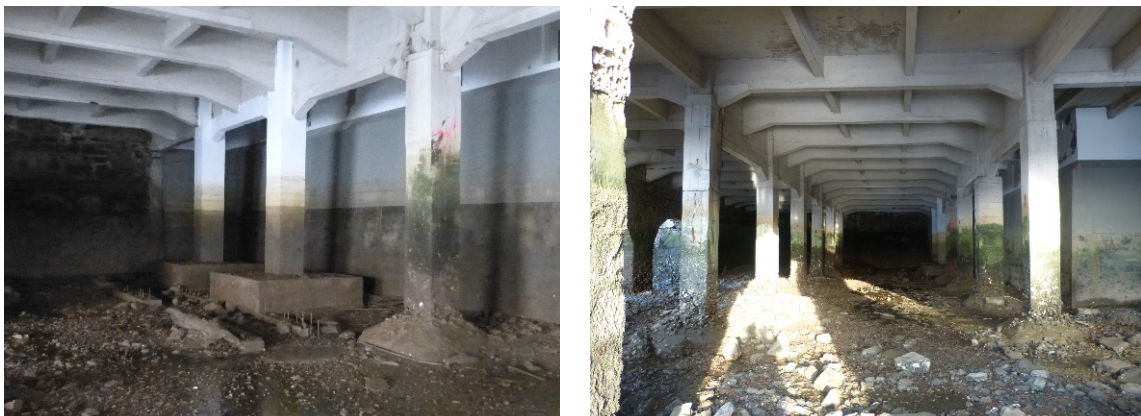
La estructura vertical en su planta inferior está formada por los ya mencionados muros del edificio, los muros originales de los muelles, el edificio preexistente recientemente remodelado y reforzado y 13 pilares originales de hormigón armado sobre zapatas troncopiramidales que apoyan directamente en el lecho rocoso (Figura 6a). De estas, dos han sido completamente reconstruidas en 2016 junto con sus pilares, mientras que numerosos pilares han sido reparados, si bien han vuelto a reproducirse los daños por corrosión en forma de fisuras longitudinales. La estructura soporte del techo de planta baja está resuelta mediante un entramado de vigas que soportan una losa maciza, todo ello en hormigón armado (Figura 6b). Pese a que su última tarea de mantenimiento y reparación estructural se efectuó en 2015, ya se observan daños por la corrosión de las armaduras. La losa inclinada de la escalera para acceso a la vivienda del farero no ha tenido tareas de rehabilitación reciente, por lo que la corrosión de armaduras es apreciablemente mayor. La otra zona del edificio que presenta daños por corrosión de armaduras se corresponde fundamentalmente con el bajo cubierta, allí donde en el pasado ha habido filtraciones de agua por fallo del sistema de cubierta, llegando a reducirse notablemente la sección de algunas armaduras.

Figura 6: a) Pilares en carrera de mareas y zapatas reconstruidas delante del muro de hormigón de refuerzo del edificio preexistente; b) esquema estructural del forjado de planta baja

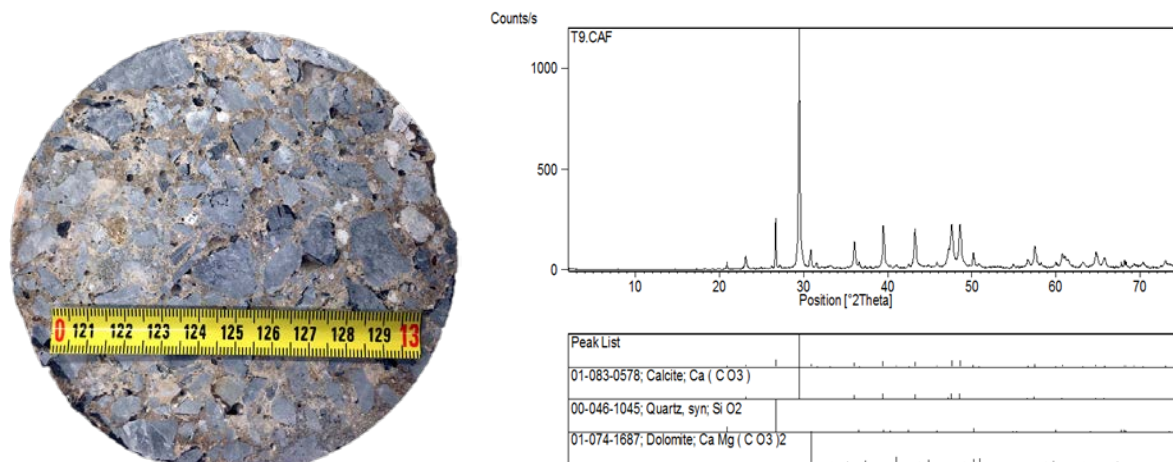
Figura 7: a) Aspecto macroscópico y b) difractograma interpretado de la muestra

El árido grueso se compone de fragmentos de caliza compuesta por calcita y algo de dolomita, mientras que la fracción fina está compuesta por arena de playa en la que se encuentran fragmentos marrones o anaranjados de organismos marinos (bioclastos) y partículas de árido silíceo rico en cuarzo (Figura 7a), confirmado mediante estudio mineralógico llevado a cabo mediante la técnica de difracción de rayos X (Figura 7b).

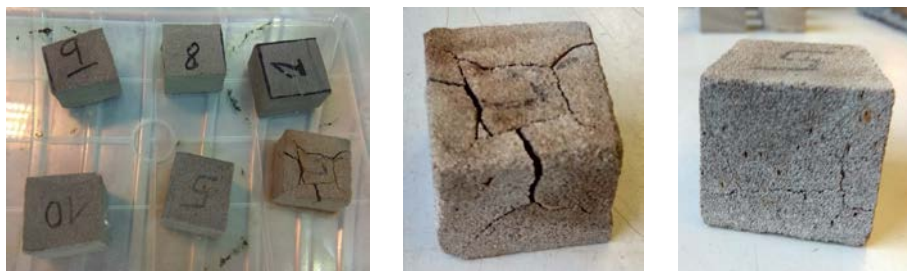
Figura 8: Muestras de piedra ensayadas tras 15 ciclos de cristalización de sales y detalle del deterioro

Los resultados de todos los ensayos han mostrado la heterogeneidad de la piedra en todas sus propiedades. Así, las mayores absorciones de agua se corresponden con las muestras dañadas en el ensayo de cristalización de sales (Figura 8). El conjunto de ensayos permite caracterizar las piedras de reposición que puedan emplearse en tareas de reposición.

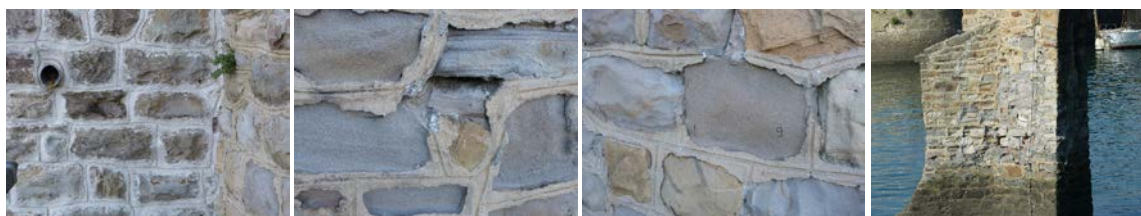
En lo referente a los morteros de rejunteo de fachada, se detectaron cuatro tipos durante la inspección visual (Figura 9): M1 correspondiente a la última intervención sobre la zona del edificio preexistente, M2 considerado no original, M3 mortero original y M4 empleado puntualmente en la base del torreón.

Figura 9: Morteros de rejunteo a) M1, b) M2, c) M3 d) M4
