# ***REHABEND 2022***

## 1. INTRODUCCIÓN

El puente que une Busturia con la isla de Txatxarramendi (figura 1) tiene una longitud aproximada de 108 metros. Salva la línea de ferrocarril Bilbao-Bermeo a su paso por Busturia, perteneciente a EuskoTren; así como la ría de Gernika, con el fin de dar acceso al tráfico rodado y peatonal desde Busturia hasta la isla de Txatxarramendi.

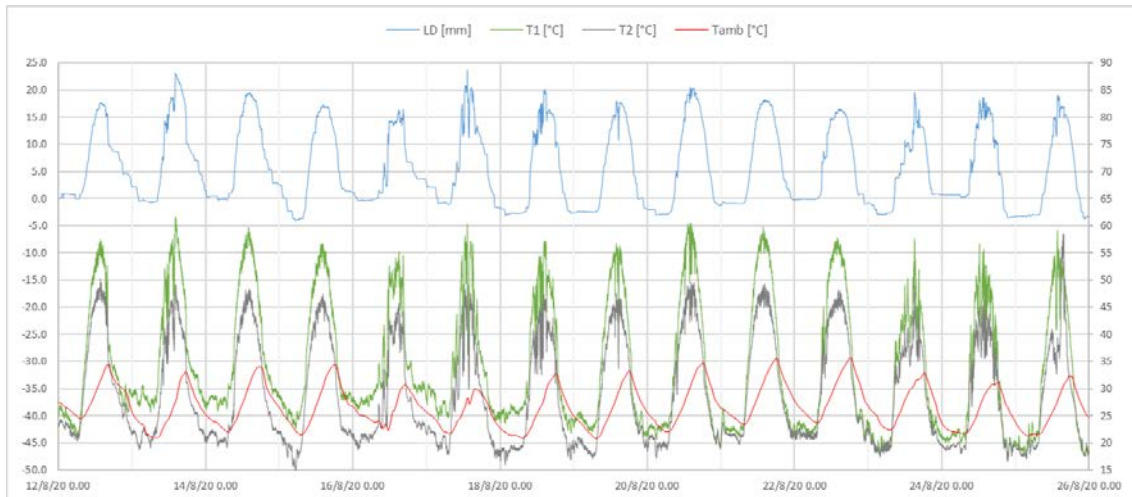
Figure 10: Qualitative roof panels elongation and temperature over time [5].

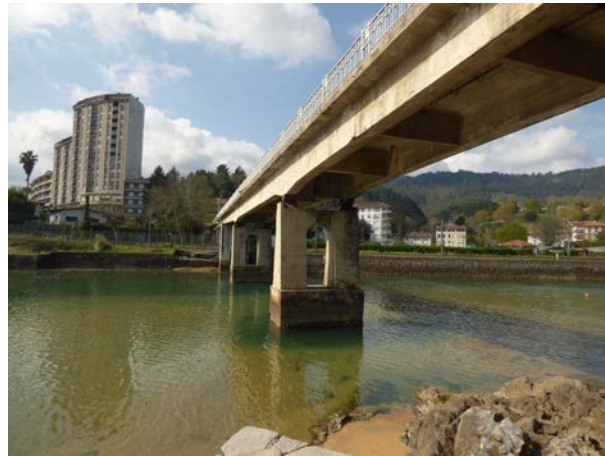
Figura 1: Vista general del puente de Txatxarramendi. Estado actual.

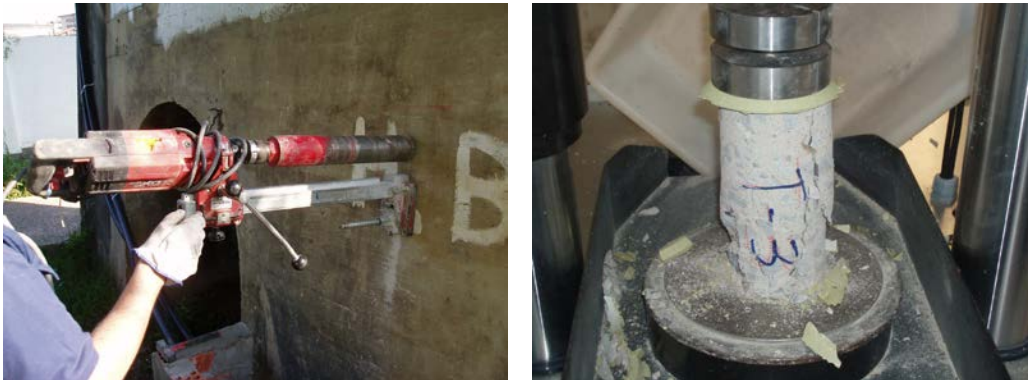
Con el fin de conocer el estado de la estructura del Puente de Txatxarramendi, en el año 2006 se realiza una inspección visual de todos los elementos que componen el mismo, registrando las patologías observadas. Asimismo, se lleva a cabo una campaña de ensayos consistente en la realización de catas bajo los apoyos de la Pila 3, así como la extracción y posterior ensayo de resistencia a compresión de varios testigos de hormigón de la estructura (figura 4).

Figura 4: Extracción y rotura a compresión de testigo de hormigón.

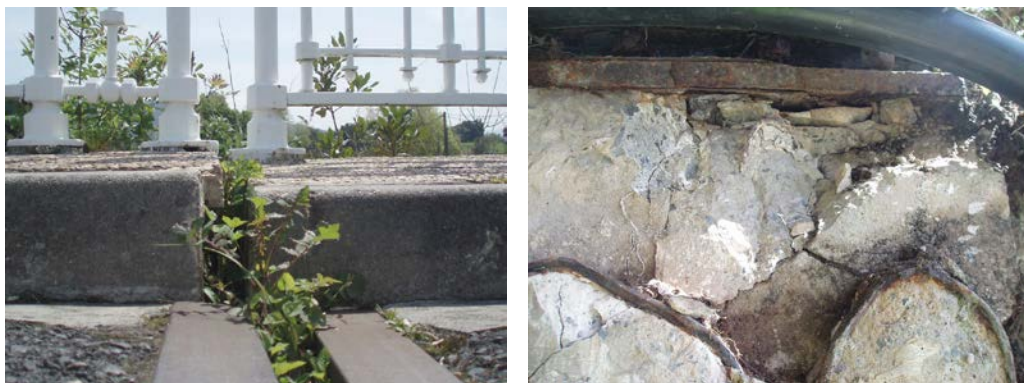
De los resultados obtenidos en este primer estudio realizado, destaca por su importancia el desnivel existente entre los dos tramos del tablero, en su unión sobre la Pila 3, debido al descenso del apoyo metálico respecto de la cara superior de la pila (figura 5). Durante la realización de las catas se observa el mal estado en el que se encuentra la zona situada bajo estos apoyos, con presencia de armadura oxidada al descubierto, fisuración, tierra, raíces, vegetación e incluso animales. La degradación de esta zona ha sido provocada en gran parte por la entrada de agua a través de la junta, debido a la ausencia de impermeabilización en la misma. Por ello, se recomienda acometer de manera urgente la reparación de la zona, para lo cual será necesario realizar el izado del tablero, en sus vanos comprendidos entre el Estribo 1 y la Pila 3.

Figura 5: Desnivel existente entre tramos de tablero, sobre Pila 3, y cata realizada bajo uno de los apoyos de dicha pila.

El problema de mayor relevancia estructural observado en 2006 se encontró en los apoyos del tablero en la pila 3 del puente. Durante los trabajos de toma de información y mediciones llevados a cabo para poder realizar el proyecto de rehabilitación, no se observan variaciones significativas del estado del apoyo respecto a lo ya observado en las inspecciones llevadas a cabo en abril de 2006, ni señales (nuevas grietas en vigas, apoyos o pilas) que conduzcan a pensar en una evolución rápida de la patología del puente.

Inicialmente el alcance de dicho proyecto de rehabilitación se limitaba a la reparación estructural de la cabeza de la pila 3 del puente, por ser éste el aspecto más relevante desde el punto de vista estructural detectado en los estudios previos. Ahora bien, al llevar a cabo la reparación de la cabeza de pila 3 es necesario retirar y recolocar, corrigiendo su posición a la que tenía antes de producirse la patología, parte de la barandilla en los dos laterales del tablero. Por este motivo y por motivos de mantenimiento y conservación, se extiende el alcance del proyecto a la reparación de anclajes defectuosos y pintado tanto de la barandilla en toda la longitud del puente, como de las farolas que componen la iluminación del mismo. Además, se incluye dentro del alcance la limpieza y actuación en imbornales de drenaje en calzada y la instalación de bajantes de drenaje en los vanos sobre terreno.

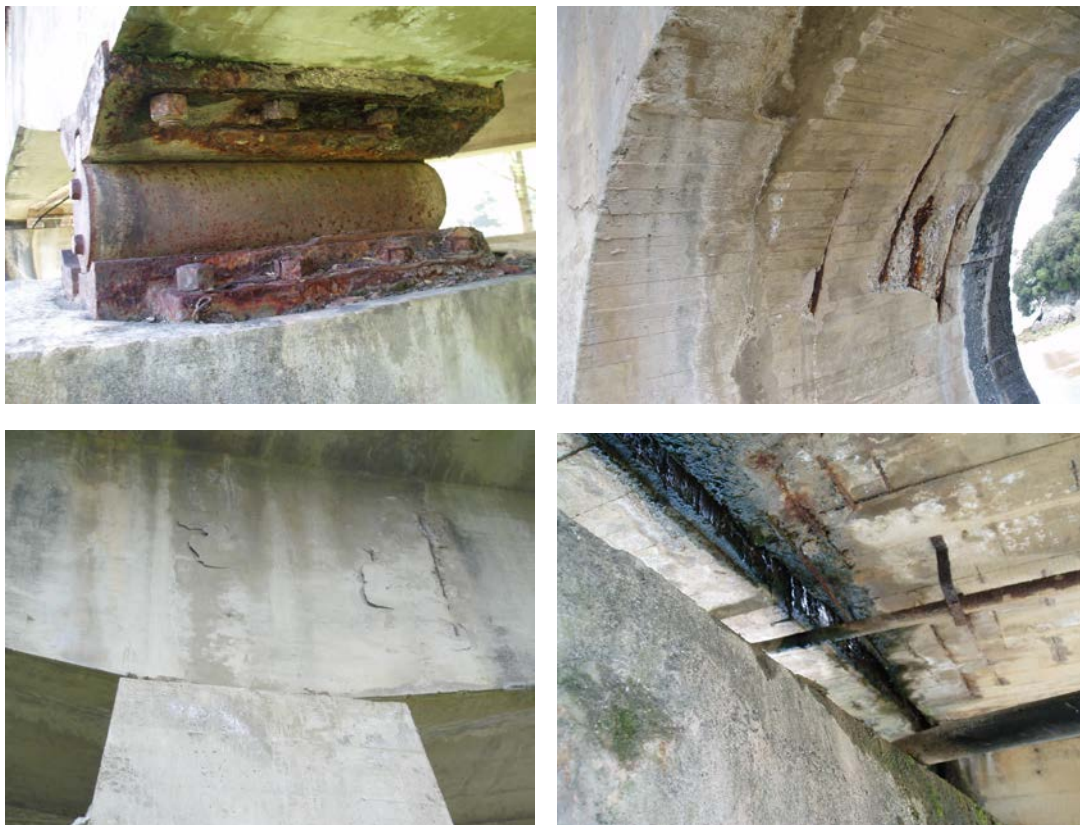
Los elementos que componen el viaducto presentan patologías similares en todos ellos. La patología más importante observada es la corrosión de las armaduras. Los efectos de la corrosión se manifiestan en forma de fisuración y desprendimiento del hormigón dejando las armaduras oxidadas al aire. En este caso, se recomienda proceder a la reparación correspondiente de los daños observados, así como proceder a una limpieza completa de las juntas mediante soplado a presión y posterior colocación de material elastomérico para evitar la entrada de agua a través de ellas.

Asimismo, existen zonas puntuales donde el recubrimiento está a punto de desprenderse, con el peligro que ello supone.

Figura 6: Ejemplos de daños observados en la estructura del puente.

Por todo ello, se concluye que debe realizarse la reparación del puente en un breve periodo de tiempo, ya que los daños pueden seguir aumentando de forma considerable (figura 6). Se indica además que, si las reparaciones no se van a realizar de forma inmediata, sí es necesario tomar medidas de seguridad frente a los posibles desprendimientos observados.

En cualquier caso, todas las reparaciones a realizar deberán recogerse de manera detallada en un Proyecto de Reparación redactado por técnicos competentes, cumpliendo lo establecido por la normativa vigente en el momento de la redacción de dicho proyecto [3, 4, 5 y 6].

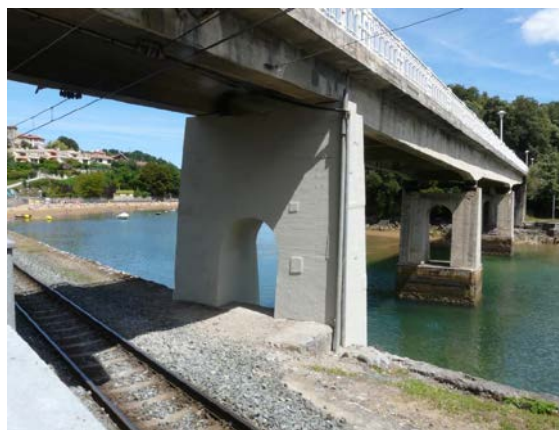
Las obras de ejecución definidas en este proyecto dieron comienzo a mediados de junio de 2013, concluyendo a finales de julio de 2013 (figura 7).

Figura 7: Estado final de la pila 3 tras la rehabilitación realizada en 2013.

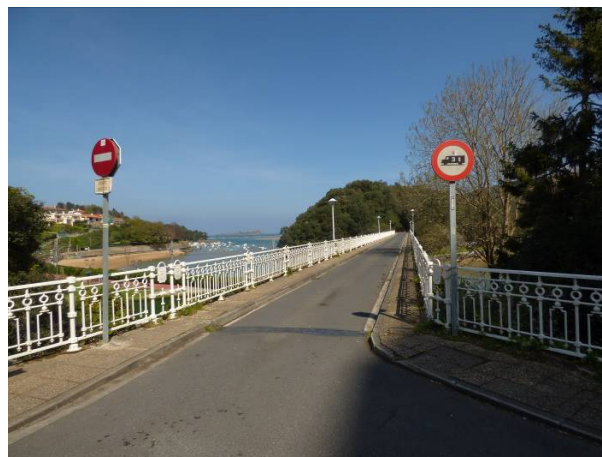
Por otro lado, para los estudios previos del presente Proyecto de Ejecución, la DIPUTACIÓN FORAL DE BIZKAIA tiene interés por poder determinar la capacidad resistente del tablero del puente, al objeto de poder contrastar si es posible que pasen vehículos de más de 3 t, que es la limitación indicada por la señalización actual dispuesta a la entrada del puente (figura 9).

Figura 9: Señal de prohibición de paso de vehículos de carga mayor a 3 t colocada en la cara superior del puente.
