# REHABEND 2022

CONSTRUCTION  
PATHOLOGY,  
REHABILITATION  
TECHNOLOGY AND  
HERITAGE MANAGEMENT

### Chimenea de Etxebarria

## Grúa nº 67

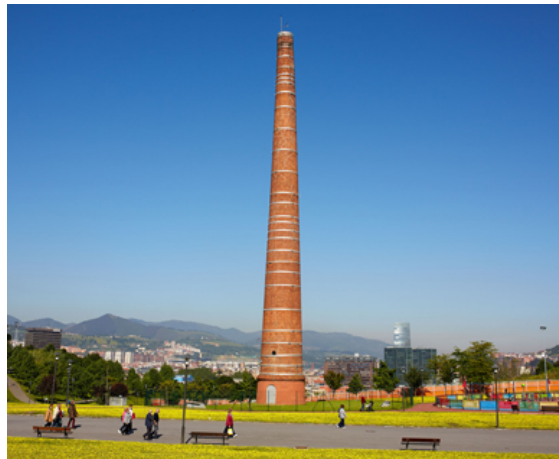
Figura 1: Chimenea de Etxebarria, vista de estado actual.

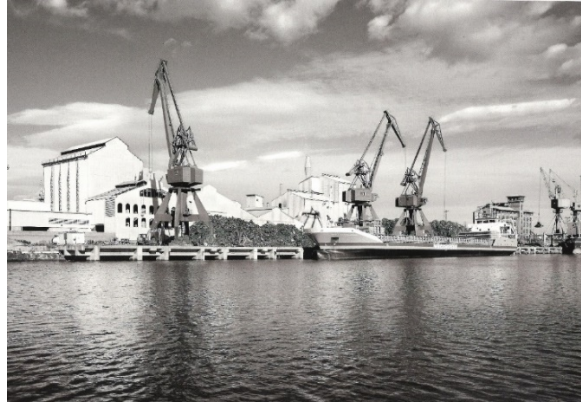
Figura 4: Las tres grúas gemelas en una imagen de hacia 1970 [3].

Las tres grúas de estiba estuvieron trabajando para la empresa Servicios Logísticos Portuarios moviendo chatarra en el muelle de Zorroza, hasta que en el año 2010 se desmontaron dos de ellas, dejando de forma solitaria en el muelle a la nº 67.

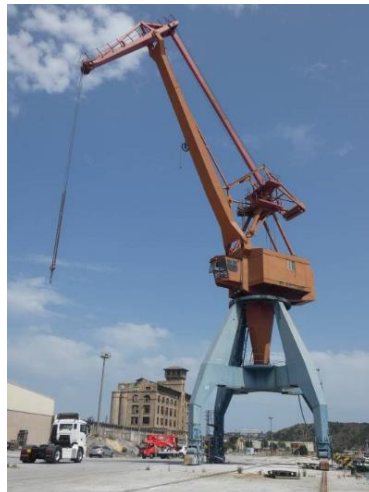
Figura 5: Imagen actual de la grúa nº 67, detrás el edificio de Molinos Vascos.

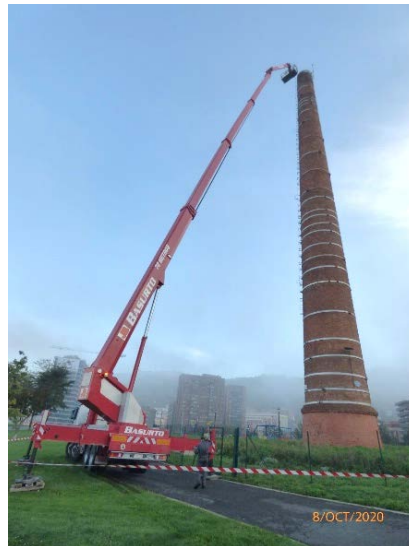
Inspección del exterior: La inspección del exterior de la chimenea se ha llevado a cabo mediante el empleo de un camión elevador con cesta, recorriéndose toda la superficie de la chimenea.

Figura 6: Vista general de la plataforma utilizada para la inspección exterior y preparación de trabajos verticales por el interior.
