REHABEND 2022

CONSTRUCTION
PATHOLOGY,
REHABILITATION
TECHNOLOGY AND
HERITAGE MANAGEMENT

17	REHABILITATION OF THE ACCESS TO THE SAN JUAN DE GAZTELUGATXE HERMITAGE <i>Baraibar, José Manuel; Escobal Marcos, Iñigo</i>	2076
24	INTEGRAL RECOVERY OF THE HERMITAGE OF SAN BLAS IN BROTO-HUESCA <i>Febas Borra, José Luís; Díez Hernández, Jesús; Rojí, Eduardo</i>	2084
80	MODEST HERITAGE PRESERVATION IN SAN SALVADOR HISTORIC CENTER. THE GREEN HOUSE REHABILITATION CASE <i>Avendaño, Ayansi</i>	2096
83	LIGHT AND SPACE - TRANSFORMING A VILLA INTO THE CHRISTIAN YOUTH CENTRE TIMISOARA <i>Andreescu, Ioan; Dinu, Dan – Răzvan</i>	2106
110	ARCHITECTURAL REHABILITATION OF THE ROOF OF THE CENTRAL COURTYARD OF THE FACULTY OF ECONOMICS AND BUSINESS SCIENCES OF THE UNIVERSITY OF SEVILLE. A CASE OF ARCHITECTURAL INTERVENTION IN MODERN HERITAGE PROPERTIES <i>Agudo Martínez, Andrés; Basallote Neto, Francisco</i>	2115
115	TECHNOLOGICAL REFURBISHMENT AND ENERGY RETROFIT OF LARGE, FLAT ROOFS BY USING METAL SHEET SYSTEMS: THE CASE STUDY OF A MULTIFUNCTIONAL BUILDING <i>Scrinzi, Giacomo; Mazzucchelli, Enrico Sergio; Stefanazzi, Alberto; Lucchini, Angelo</i>	2129

CODE 24

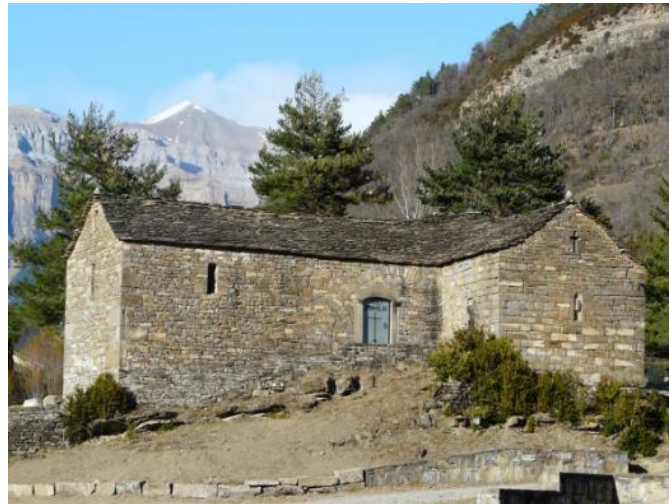
Figura 2: Detalle de la ermita de San Blas antes del inicio de las obras.

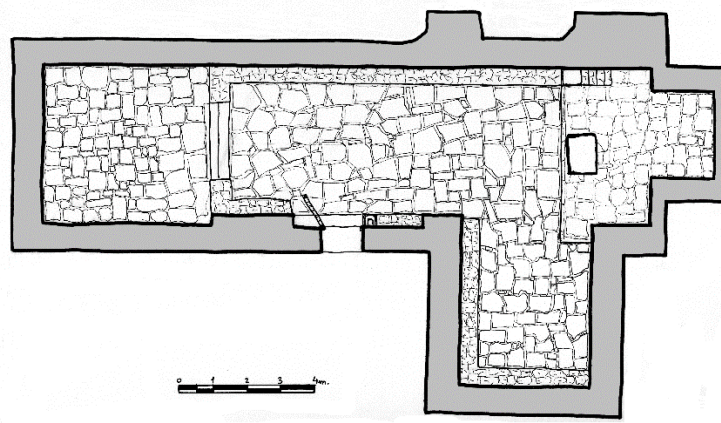
Se trata de un edificio cuya planta es abigarrada con una forma de cruz latina a la que le falta el brazo norte y una alargada nave elevada sobre basamento macizo para poder salvar el desnivel existente a los pies del templo. La nave en planta, en disposición longitudinal Este-Oeste, cuenta con unas dimensiones exteriores de 21,15 metros de largo y de 6,16 metros de ancho, con unas dimensiones interiores de 18,50 metros de largo por entre 4,74 y 4,88 metros de anchura. La nave del brazo Sur tiene unas dimensiones exteriores de entre 4,72 y 4,88 metros de longitud por 5,65 metros de anchura, siendo en el interior su anchura de 3,72 metros. [3]

Figura 3: Plano en planta de la ermita de San Blas

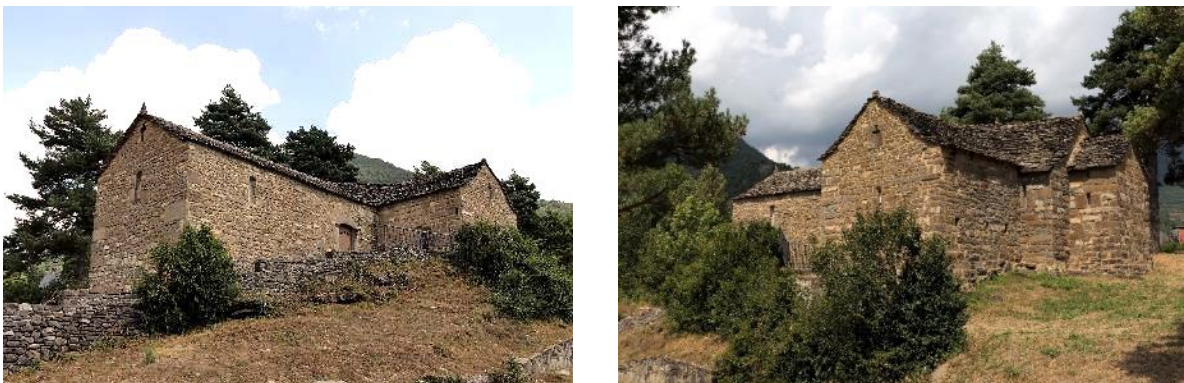
Figura 4: Fachadas Oeste y Sur, y fachadas Sur y Este.

Las paredes de fábrica de piedra en aparejo de sillería, sillarejos y mampostería irregular, dependiendo de la zona del templo, se encontraban rejuntadas solo en algunas zonas puntuales. Las cubiertas de la ermita son a dos aguas con acabado en losa de piedra del país.

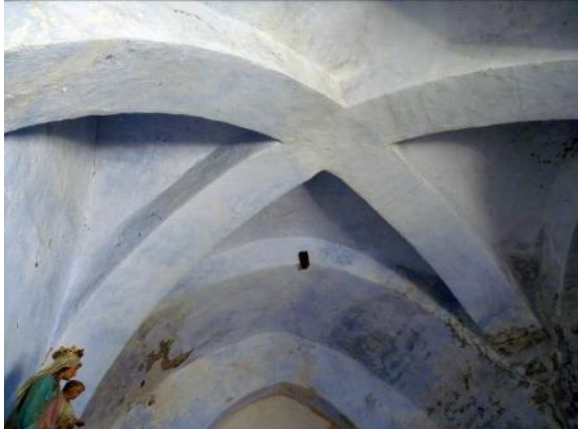
El ábside se cubre por bóveda de crucería con arcos fajones diagonales lisos y plementería entre ellos, todo originalmente revocado y pintado en blanco azulado. El cuerpo a los pies de la nave principal se cubre por tejado a dos aguas con estructura de madera vista en tijera sin pendolón, pares y entablado, todo sin pintar. Las piezas están formadas por piezas de madera en bruto sin escuadrar. La nave del brazo Sur se cubre con bóveda de cañón apuntada.

Figura 7: Bóveda de crucería en el ábside

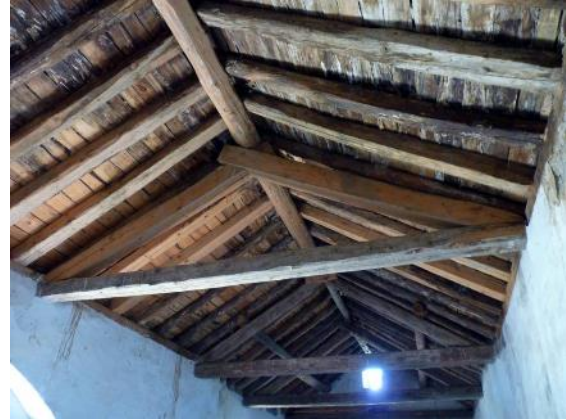
Figura 8: Cubierta del cuerpo de la nave principal

En 2013 se ejecutan los siguientes trabajos: reconstrucción del tejado de la nave principal con madera y losas de piedra, excavaciones arqueológicas por parte de D. José Ignacio Lorenzo, arqueólogo de la Dirección General de Patrimonio del Gobierno de Aragón, recolocación del suelo del ábside y del presbiterio, construcción de bancales de madera en el coro y nave reaprovechando la madera del antiguo tejado, colocación de placas de alabastro en los huecos de las ventanas, reacondicionamiento de la puerta de entrada, instalación eléctrica y enalado del interior, colocación del altar románico y de la reproducción a tamaño natural del retablo del siglo XV. El día 23 de agosto el Obispo de Jaca y Huesca, D. Julián Ruíz Martorell, reconsagra solemnemente el altar mayor en el marco del II Encuentro de la Asociación.

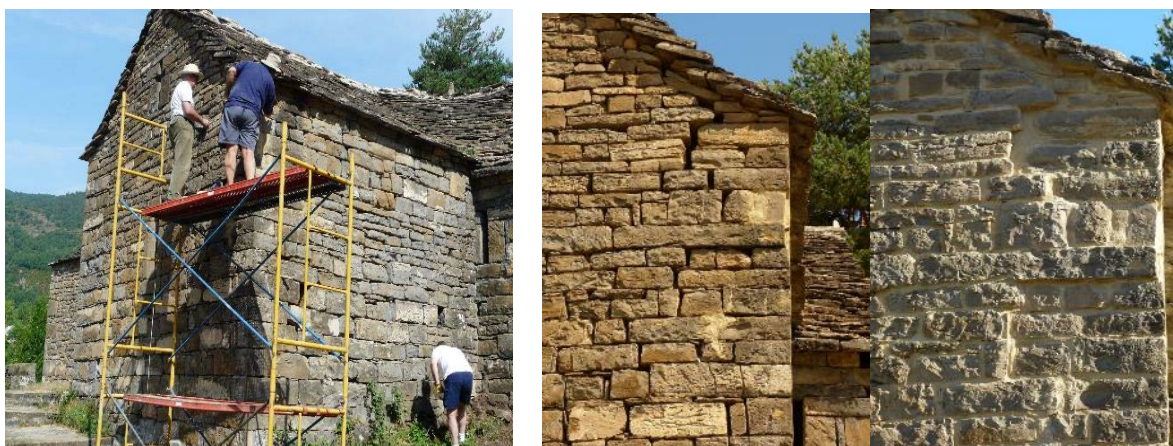
Figura 11: Trabajos de consolidación estructural.

En 2012 se inician las obras con la consolidación estructural de la esquina de la capilla gótica, el arreglo del tejado sobre la parte abovedada, así como la supresión del tabique y del altar de mampostería. Tienen lugar el hallazgo de la lipsanoteca y el descubrimiento casual de la pintura de San Cristóbal en el muro sur de la capilla gótica.

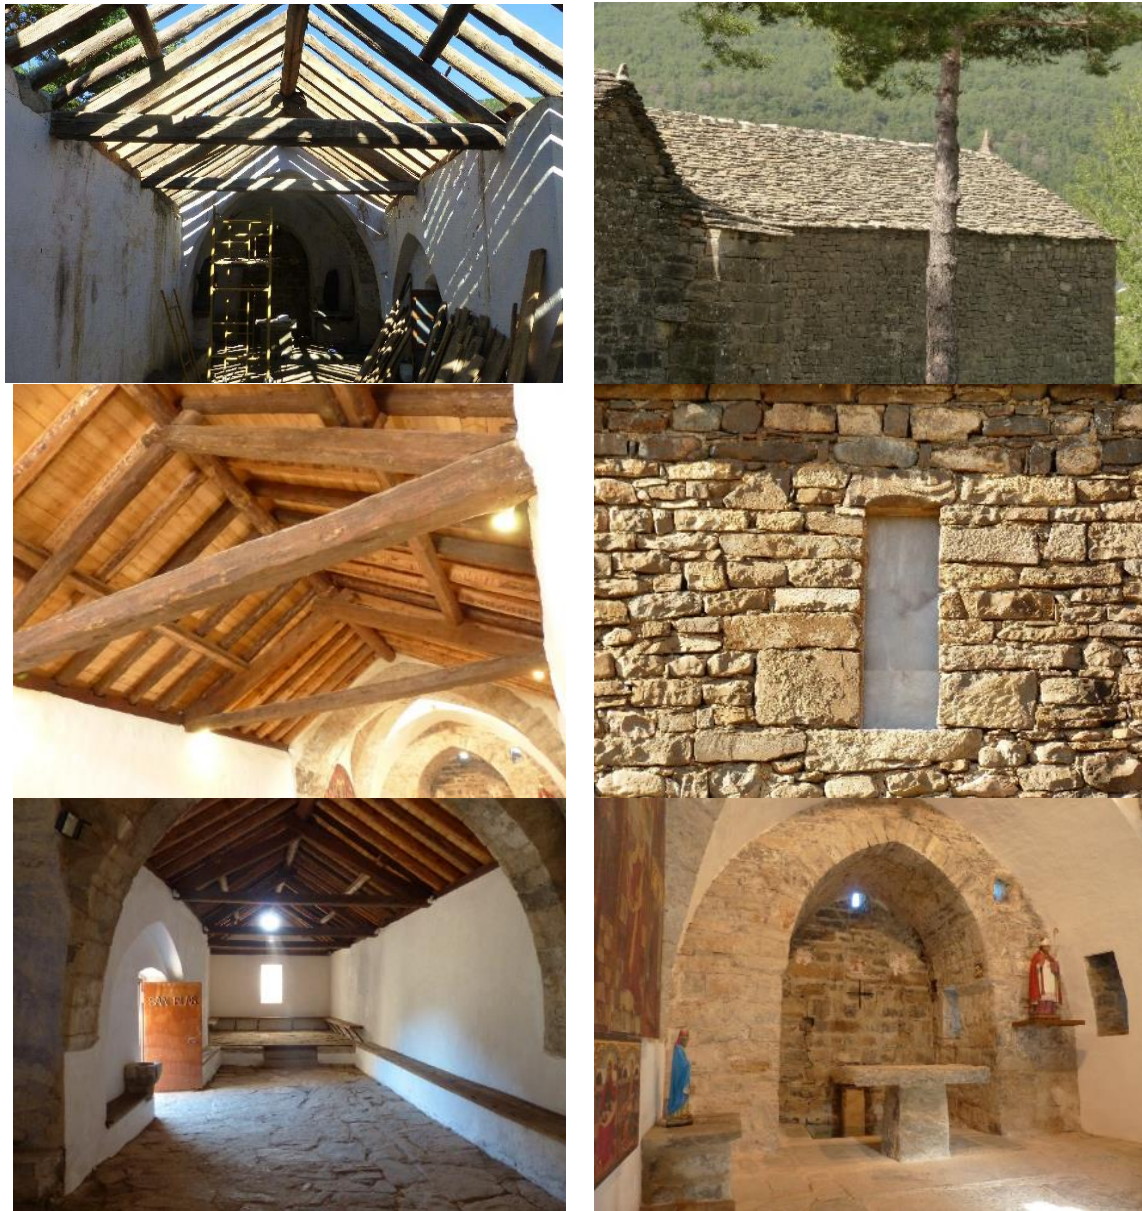
Figura 12: Trabajos del verano de 2013.

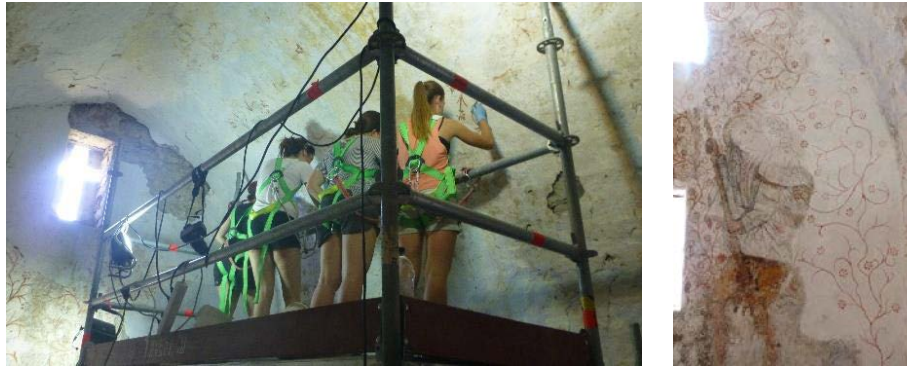
Figura 13: Trabajos de restauración de las pinturas.

En 2017 y 2018 tienen lugar las fases 1ª y 2ª de la recuperación de las pinturas de la capilla gótica, tras consolidar el revoco original y sacar a la luz las pinturas ocultas tras las diferentes capas de cal. La realiza, de la mano del profesor Guillermo Torres, un nutrido grupo de alumnos de la ESCRBCA (Escuela Superior de Conservación y Restauración de Bienes Culturales de Aragón), dependiente de la DGA y con sede en Huesca. Se descubre la hornacina en cuyo interior aparecen restos que serán estudiados y restaurados en la misma escuela.

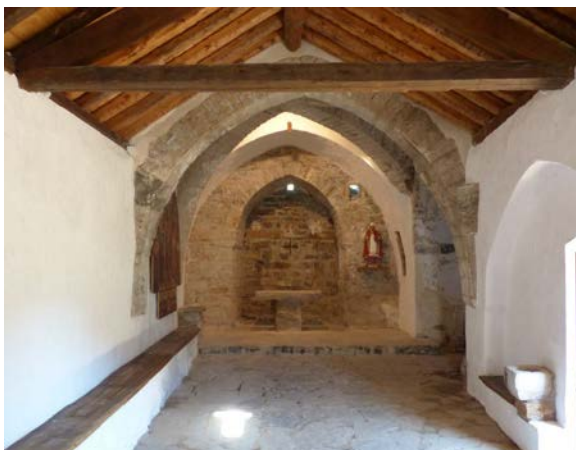
Figura 15: Vista hacia el presbiterio de la ermita tras la terminación de la restauración.

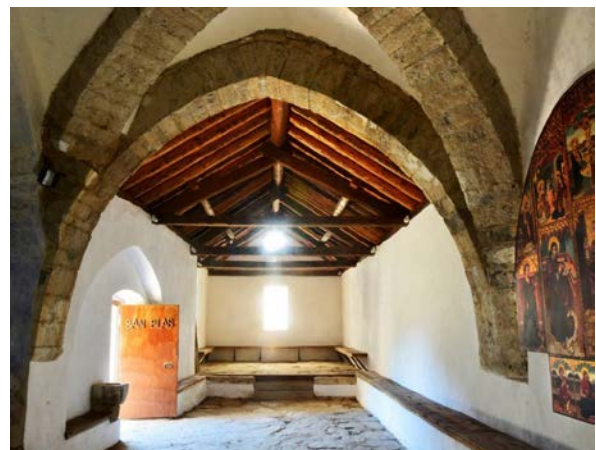
Figura 16: Vista de la nave principal de la ermita tras la restauración.
