REHABEND 2022

CONSTRUCTION
PATHOLOGY,
REHABILITATION
TECHNOLOGY AND
HERITAGE MANAGEMENT

Granada (Spain) - September 13th-16th, 2022

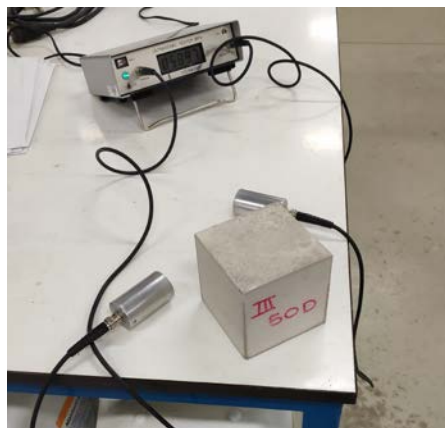
Figure 1: UPV device.

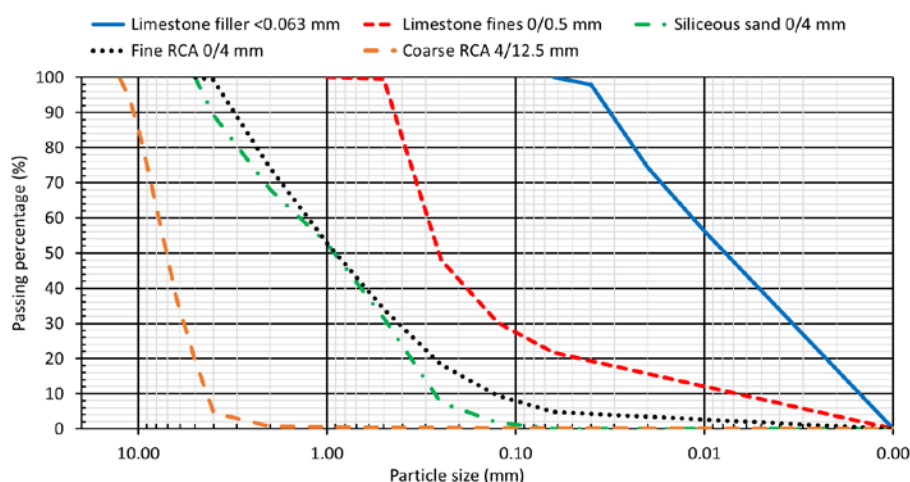
Figure 2: Particle gradation of the aggregates.

All mixes were made with 100% coarse RCA 4/12.5 mm. The fine aggregate fraction consisted of siliceous sand 0/4 mm and/or fine RCA 0/4 mm (replacement percentages of the NA with RCA: 0%, 50% and 100%). Both RCA fractions were obtained by crushing precast concrete elements. The compressive strength of the parent concrete was 45 MPa. The physical properties of the aggregates are shown in Table 1. As expected, the RCA was lighter and had a higher water absorption than the NA [8]. Its particle size was continuous (Figure 2), thus suitable for the manufacture of concrete.

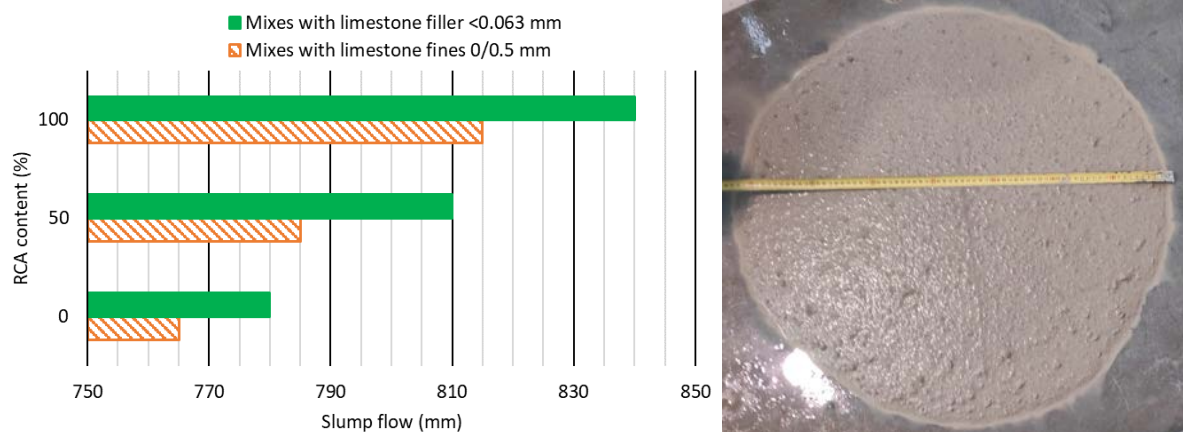
All the mixes presented a slump-flow class SF3, as shown in Figure 3. Therefore, it can be observed that the use of large amounts of RCA (100% coarse RCA and up to 100% fine RCA) did not prevent the production of a concrete with high self-compactability if a proper design of the SCC was conducted. Each modification in the raw materials used to produce the SCC affected its filling capacity:

Figure 3: Slump flow of the mixes (left); slump-flow test of mix 0/L (right).

- The addition of fine RCA increased the slump flow. Although this residue presented a more irregular shape than siliceous sand and a higher water absorption [10], its higher fines content compensated for these negative aspects and improved the fresh performance.
- On the other hand, the use of limestone filler <0.063 mm resulted in a higher slump flow of SCC. The larger particle size of the limestone fines 0/0.5 mm and their more irregular shape hindered their flow and slightly reduced the flowability of the SCC [8].

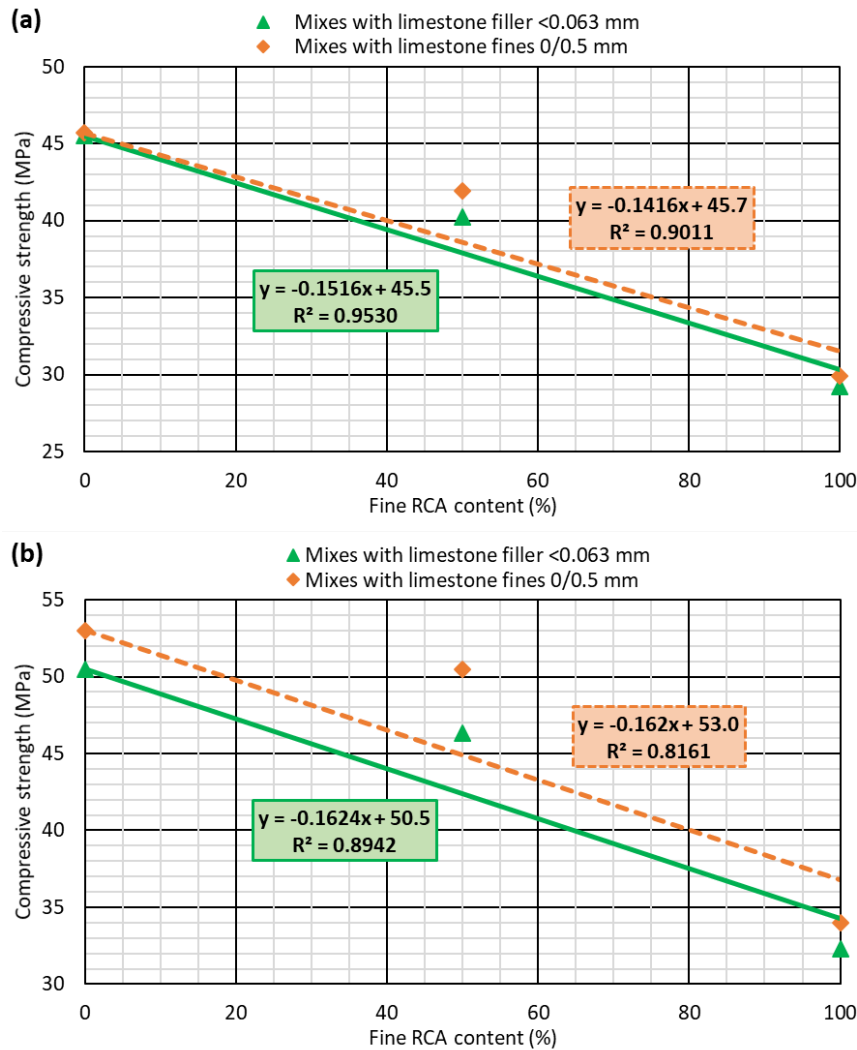
The 7- and 28-day compressive strength of the mixes is shown in Figure 4. All the mixtures exhibited a suitable compressive strength for structural use [13], although the use of fine RCA caused an approximately linear decrease in strength due to the presence of adhered mortar in the coarser particles, the existence of altered mortar particles in the finer fraction, and the increase of porosity of the cementitious matrix that its use caused [14]. In accordance with this linear trend, the decrease in strength caused by the addition of 50% fine RCA was lower than expected, with the addition of 100% fine RCA being much more harmful.

Figure 4: Compressive strength of the mixes: (a) 7 days; (b) 28 days.

Regarding the aggregate powder, the mixtures with limestone fines 0/0.5 mm had a higher compressive strength. This is explained by the fact that limestone fines 0/0.5 mm allowed the creation of a higher quality cementitious matrix [15]. In addition, their higher water absorption (Table 1) allowed for greater internal curing [15], which caused a more noticeable increase in strength from 7 to 28 days.

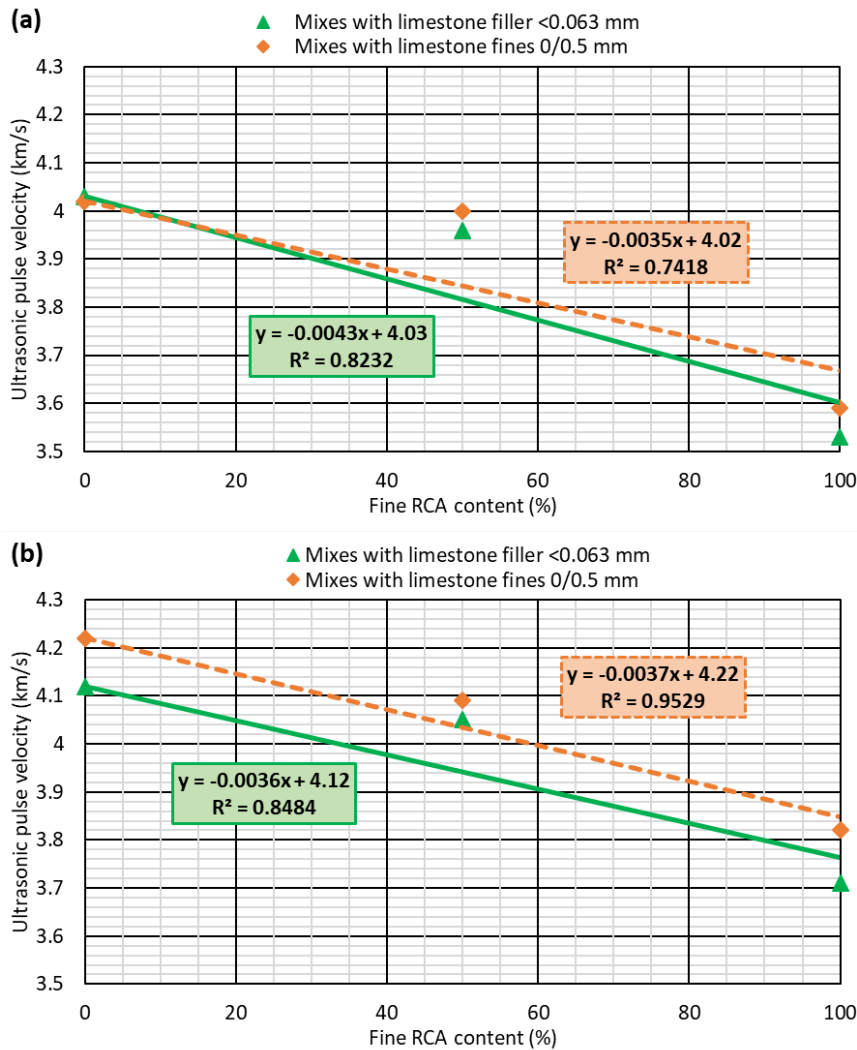
The UPV of the mixes at both 7 and 28 days is shown in Figure 5. The values obtained corresponded to a concrete of adequate quality for structural use, although, according to the equivalence between compressive strength and UPV exposed in the introduction, slightly higher than expected [6]. A number of aspects also shown in the compressive strength can be observed in the results obtained:

Figure 5: Ultrasonic pulse velocity of the mixes: (a) 7 days; (b) 28 days.

- First, the UPV increased with age, being higher at 28 days than at 7 days. The development of strength over time by the cementitious matrix explains this behavior [5].
- Second, increasing the fine RCA content of SCC led to a decrease in UPV. This decrease was due to the increased porosity of the cementitious matrix when adding fine RCA and to the lower density of this waste compared to NA [14]. This decrease exhibited a linear trend, especially at 28 days.
- Finally, the use of limestone fines 0/0.5 mm increased the UPV because it created a higher quality cementitious matrix [15]. As with compressive strength, this increase was especially notable at 28 days.
