REHABEND 2022

CONSTRUCTION
PATHOLOGY,
REHABILITATION
TECHNOLOGY AND
HERITAGE MANAGEMENT

Granada (Spain) - September 13th-16th, 2022

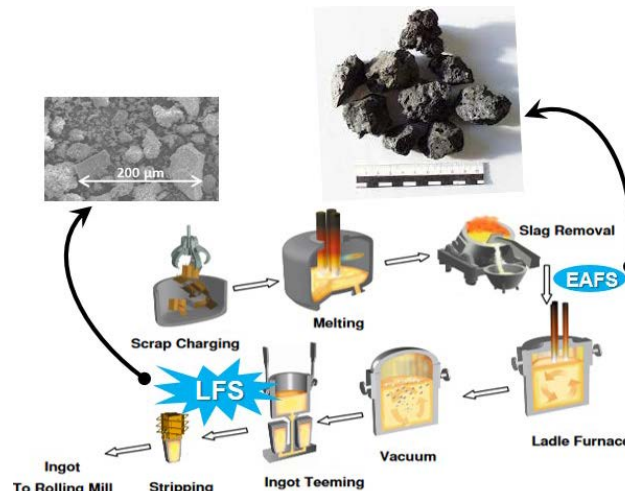
Figure 1: Electric arc furnace steel-making process.

The steel-making industry manufactures steel products through the electric steelworks and generates two fundamental types of slag (solid supernatant in liquid steel). The first, black slag (EAFS - Electric Arc Furnace Slag) is a 1st-degree fusion slag due to acidic oxidation in electric arc furnaces melting scrap, with a stony appearance (black) and a gravel-like geometry. It is heavy (20% denser than natural aggregate), porous, hard and of diverse granulometries, ranging from millimetres to several decimetres (Figure 1). The second one, called white slag (LFS - Ladle Furnace Slag), basic in nature, is generated in a ladle furnace (secondary metallurgy, steel refining) with (in general) a powdery appearance, high chemical/crystalline complexity and reactive in water and cement matrices [1].
